**Flood Control Project Maintenance  
Levee Inspections**  
**LMA District Cover Sheet**  
**Spring 2018 Levee Inspection Results**

**Yolo County Department of Natural Resources**

**Levee Inspection Report By Mile - Spring 2018**

Waterway	Bank	Unit Miles	Inspection Start/End	Inspector
Unit No. 01 Right Bank Cache Creek	Right	0.59	03/07/2018 03/07/2018	Zach Jojola

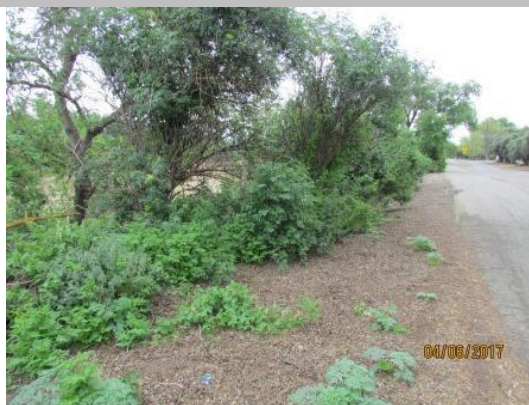
Photo 2 of 2 : SP\_2018\_NA0021\_351\_23\_20180306\_00019.jpg

Wild vegetation on waterside levee slope, blocking visibility. Spring 2017.

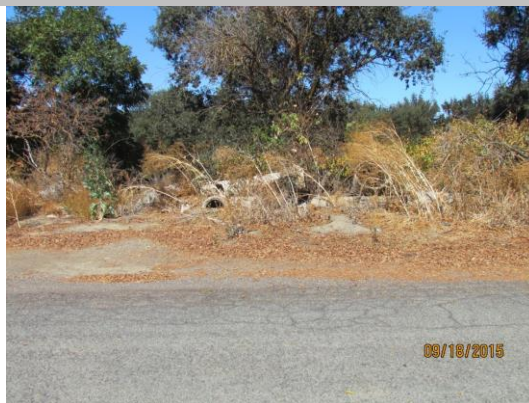
Photo 1 of 1 : SP\_2018\_NA0021\_351\_15\_20180306\_00010.jpg

LM Start	0.03	Rating **	M	Issue No.	15
LM End	0.03	Issue Type +	Ma	Location *	WS
Category	Earthen Levee			GPS Latitude/Longitude	
				Start	End
Item	Encroachments			38.720895 °	38.720895 °
				-121.810408 °	-121.810408 °
DWR ID	DWR_NA0021_01_f_2015_15				
Comment Code					
DE : Debris					
Inspector Comment					
Concrete pipes on waterside slope.

View of the debris on the waterward side of the levee. Fall 2015.

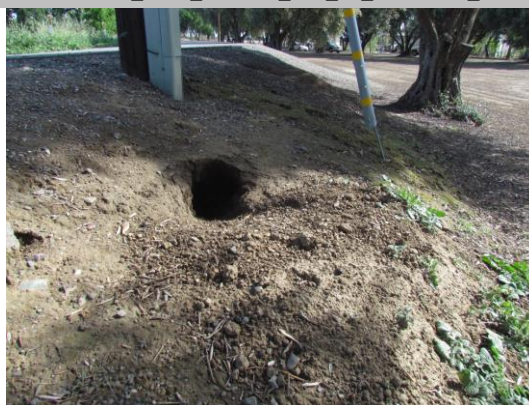
Photo 2 of 3 : SP\_2018\_NA0021\_351\_16\_20180306\_00012.jpg

View of the rodent hole on the landward side of the levee looking downstream. Spring 2015.

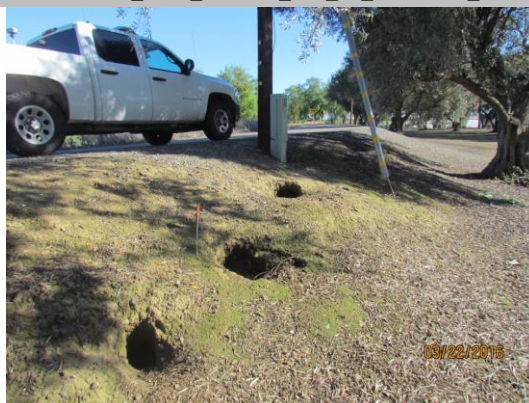
Photo 3 of 3 : SP\_2018\_NA0021\_351\_16\_20180306\_00013.jpg

View of the rodent holes on the landward side of the levee looking downstream. Spring 2016.

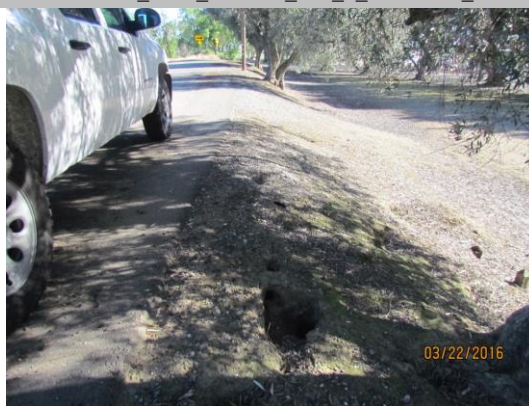
Photo 1 of 2 : SP\_2018\_NA0021\_351\_7\_20180306\_00005.jpg

LM Start	0.20	Rating **	M	Issue No.	7
LM End	0.20	Issue Type +	Ma	Location *	LS
Category	Earthen Levee			GPS Latitude/Longitude	
				Start	End
Item	Animal Control			38.721683 °	38.721683 °
				-121.807532 °	-121.807532 °
DWR ID	DWR_NA0021_01_s_2016_7				
Comment Code					
A3 : No rodents visible, but rodent burrows visible; need to backfill and compact or grout burrows.					
Inspector Comment

Perspective view of the rodent hole on the landward side of the levee looking downstream. Spring 2016.

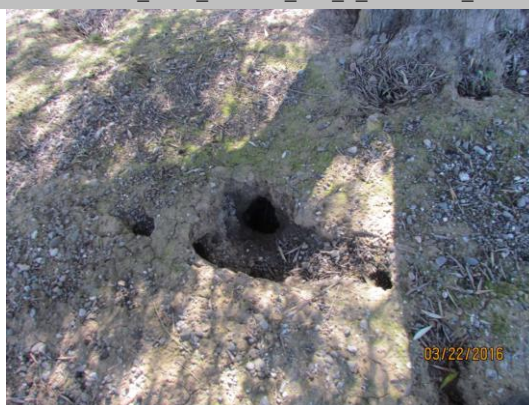
Photo 2 of 2 : SP\_2018\_NA0021\_351\_7\_20180306\_00006.jpg

Animal hole is close to the shoulder of the levee. Spring 2016.

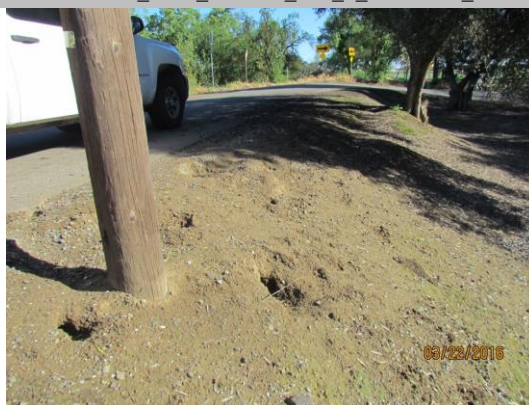
Photo 1 of 1 : SP\_2018\_NA0021\_351\_8\_20180306\_00007.jpg

LM Start	0.22	Rating **	M	Issue No.	8
LM End	0.22	Issue Type +	Ma	Location *	LS
Category	Earthen Levee			GPS Latitude/Longitude	
				Start	End
Item	Animal Control			38.721876 °	38.721876 °
				-121.807393 °	-121.807393 °
DWR ID	DWR_NA0021_01_s_2016_8				
Comment Code					
A3 : No rodents visible, but rodent burrows visible; need to backfill and compact or grout burrows.					
Inspector Comment

View of the rodent holes on the landward side of the levee looking downstream. Spring 2016.

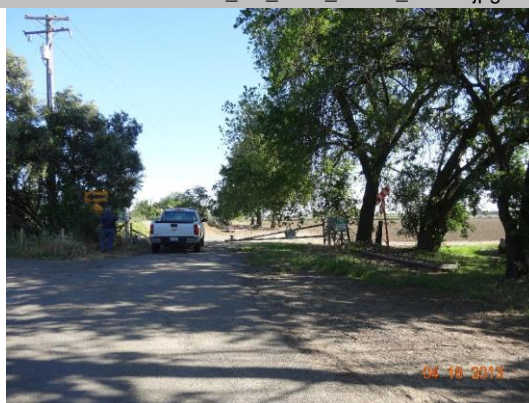
Photo 1 of 3 : UCIP\_SP\_2018\_39855\_69553.jpg

Comment Code					
Inspector Comment					
FS_ID:39855					
DS_ID:19554					
EP_NO: 6790					
Repair Type: Non-Urgent					
Crossing Status: Indicator Found					
UCIP Comments: Need to contact owner to determine if crossing is still active and to determine last inspection date. Will need copy of letter showing crossings passed inspection.					
FIELD_STRUCT_DESC: 6-inch steel natural gas pipeline through the levee, 4 feet below the crown. Pipe extends from borrow area and under the channel. Bleeder valve on the waterside (WS) bank. Service vault located on the landside (LS) next to access gate. Paved access ramp on the LS slope. (Plans to lower a 6-inch high-pressure gas main crossing Cache Creek authorized under Permit No. 6790, 1969 - Pacific Gas and Electric Company [PG&E]). [Additional Reference(s): DWR Levee Log, 2004].					
FS Date: 4/16/2013

View of landward side near access gate. Gas line marker located on between trees. Line runs parallel to access roadway and through levee.

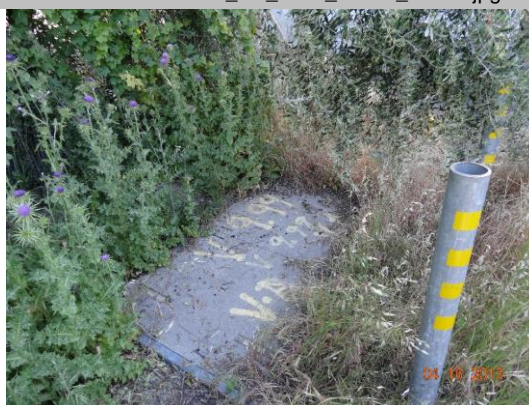
Photo 2 of 3 : UCIP\_SP\_2018\_39855\_69554.jpg

Service vault located on landward toe near gate access gate.

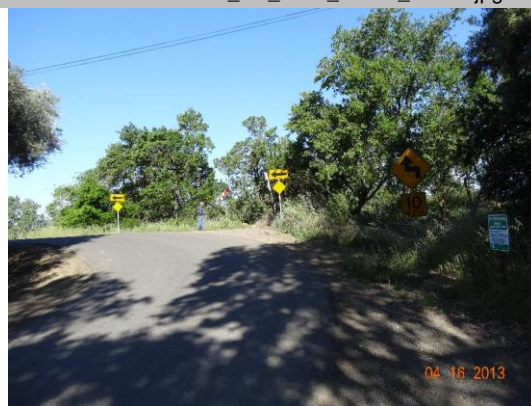
Photo 3 of 3 : UCIP\_SP\_2018\_39855\_69555.jpg

Comment Code						
Inspector Comment						
FS_ID:39855						
DS_ID:19554						
EP_NO: 6790						
Repair Type: Non-Urgent						
Crossing Status: Indicator Found						
UCIP Comments: Need to contact owner to determine if crossing is still active and to determine last inspection date. Will need copy of letter showing crossings passed inspection.						
FIELD_STRUCT_DESC: 6-inch steel natural gas pipeline through the levee, 4 feet below the crown. Pipe extends from borrow area and under the channel. Bleeder valve on the waterside (WS) bank. Service vault located on the landside (LS) next to access gate. Paved access ramp on the LS slope. (Plans to lower a 6-inch high-pressure gas main crossing Cache Creek authorized under Permit No. 6790, 1969 - Pacific Gas and Electric Company [PG&E]). [Additional Reference(s): DWR Levee Log, 2004].						
FS Date: 4/16/2013

View of gas line marker located on levee crown.

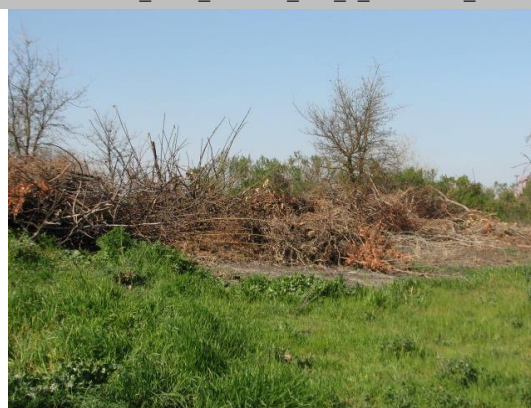
Photo 1 of 3 : SP\_2018\_NA0021\_351\_4\_20180306\_00002.jpg

LM Start	0.27	Rating **	M	Issue No.	4
LM End	0.27	Issue Type +	Ma	Location *	WS
Category	Earthen Levee			GPS Latitude/Longitude	
				Start	End
Item	Encroachments			38.722520 °	38.722520 °
				-121.806991 °	-121.806991 °
DWR ID	DWR_NA0021_01_s_2012_4				
Comment Code					
PR : Prunings					
Inspector Comment

A continuous brush pile on levee. Spring 2013

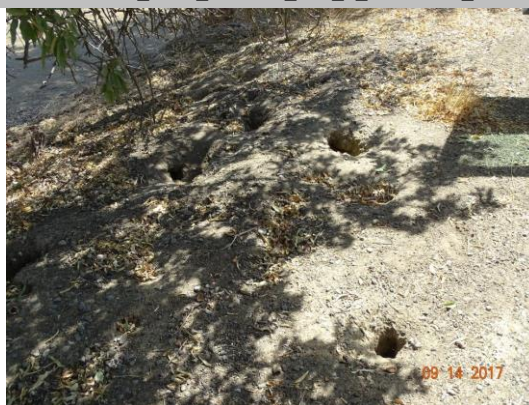
Photo 1 of 1 : SP\_2018\_NA0021\_351\_3\_20180306\_00001.jpg

LM Start	0.45	Rating **	M	Issue No.	3
LM End	0.45	Issue Type +	Ma	Location *	LS
Category	Earthen Levee			GPS Latitude/Longitude	
				Start	End
Item	Animal Control			38.725115 °	38.725115 °
				-121.806527 °	-121.806527 °
DWR ID	DWR_NA0021_01_f_2017_3				
Comment Code					
A3 : No rodents visible, but rodent burrows visible; need to backfill and compact or grout burrows.					
Inspector Comment

Rodent holes on landward hinge point. Fall 2017.
